Fiberglass Boat Repair Training on Meosbekwan Island, Ayau Islands, Raja Ampat

Rezza Ruzuqi^{1,a)}, Muh. Akhsan Samaila²⁾, Irman Amri³⁾, Arief Nasrul Firdani⁴⁾, Safriansyah⁵⁾

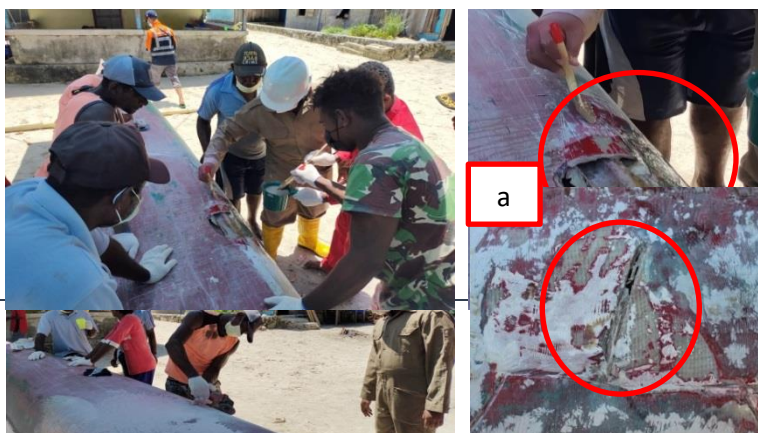
The most important thing is to see the problem at hand first. In this activity, the cases encountered were on the right and left lower hull. The right lower hull suffered severe damage, namely experiencing a hole in the loss of material. The lower left hull only experienced a slight scratch. Figures 6a and 6b show the process of opening the outermost layer of material that was badly damaged on the right lower hull and left lower hull, respectively.

Figure 6. a) Damage to the right lower hull; b) Damage to the left lower hull

Then for the number and arrangement of laminations used in the implementation of Community Service (PkM) on Meosbekwan Island, there is a difference in the number and lamination layout based on the level of damage to the ship handled. When viewed from the case, the lower left hull suffered pretty bad damage compared to the right lower hull. Based on this case, for the lower left hull, get the number and arrangement of laminations as much as five. As for the right lower hull, the number and lamination layout are four. The number and lamination layout has four and five layers, as shown in Tables 1 and 2 (Rezza, 2020-2).

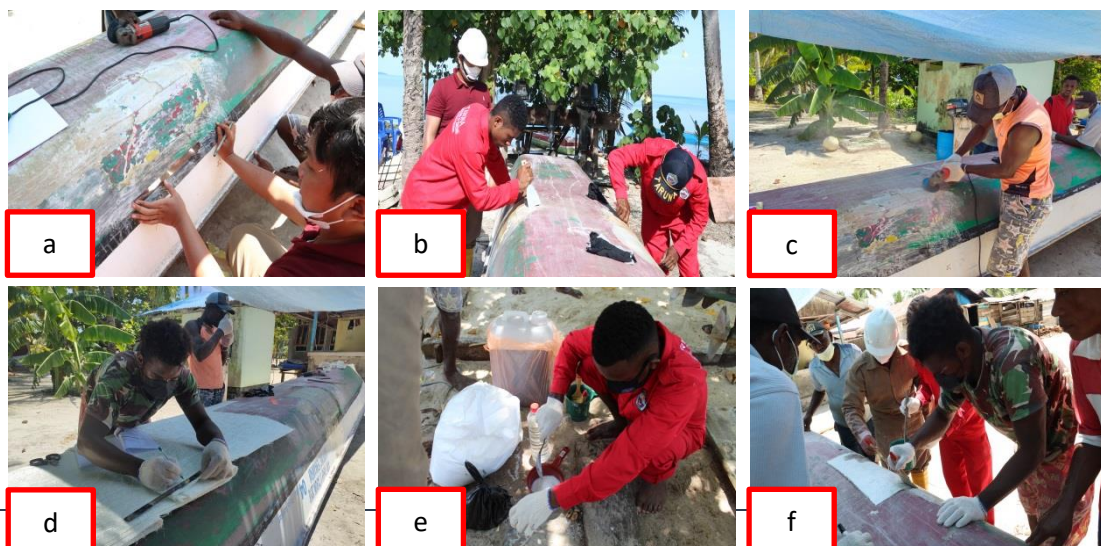
Figure 9. Fiberglass boat repair process; a) Measuring the area of damage; b) Looking for a hard surface; c) File the damaged surface; d) Measuring material requirements; e) Mixing ingredients; and e) Patching process

After completing these activities, practical activities continued with repairing fiberglass boats. Figure 9. shows the process In the repair stage, starting with measuring the area of damage and marking it so that it is more effective and efficient in using materials. Then, the damaged layer is scraped using a grinder so that patch, the damaged part is not left behind. After that, rub the surface using sandpaper to make it easy to patch. Cut the fiberglass material and measure the resin catalyst as needed. Then, Patch the damaged part and wait for it to dry. After that, do caulking to produce a neat surface. In this opportunity, the caulking process could not done because the putty material was behind on Campus.

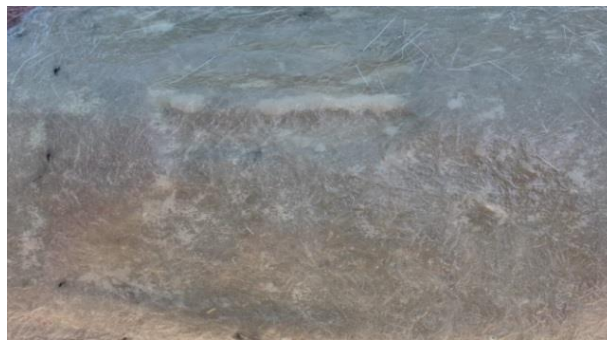
The repair results show that the patch material sticks well. Figure 10 shows the results of fiberglass boat patches. It appears that the patch results are perfectly covered. The results of these patches should be followed by a caulking process to produce a neater and denser surface. On this occasion, Community Service activities in Meosbekwan village only improved. The number of layers of material is also strong enough to withstand the blows of seawater. However, in that case, it should be followed by repairs to the inside of the ship. It is because, in this case, the damage to the boat was very serious. So it needs to be strengthened with deep patches. And for the process of repairing the inside of the boat on this occasion has not been carried out due to the limited time given. Therefore, on this occasion, only external patching was carried out.

Figure 10. Results of fiberglass boat patches
