## Testing the Electrical Safety Aspects of The Emergency Shut Down Multi Indicator (Esin) Innovation Tool for Refueling De-Refueling Trucks (RDT) at The Mutiara Palu Aircraft Filling Depot

Electrical Engineering Study Program, Faculty of Engineering, Tadulako University, Palu, Indonesia

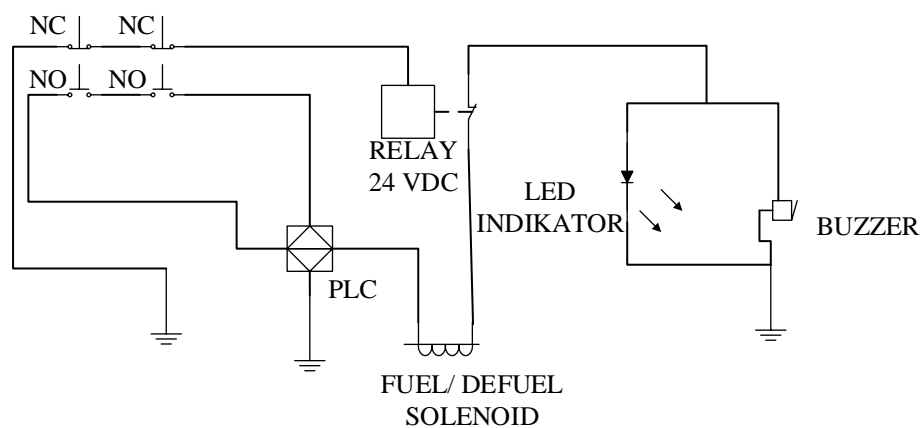
**FIGURE 2.** Single line diagram of the ESI system

Figure 2 is a picture of the ESI installation. The working principle of ESI is to activate the LED indicator light and buzzer if the contractor is active. The contractor is active if one or both emergency switches are active when pressed. These emergencies are emergency fuel stops and emergency engine stops, which are represented by the NC and NO push buttons for each emergency. If the emergency engine stop is pressed, the NC on the negative line will also be active so that the contractor is active. This is what is expected to happen so that there are indicators that can be seen and heard by officers to provide a quick warning of any disturbances in avtur filling.

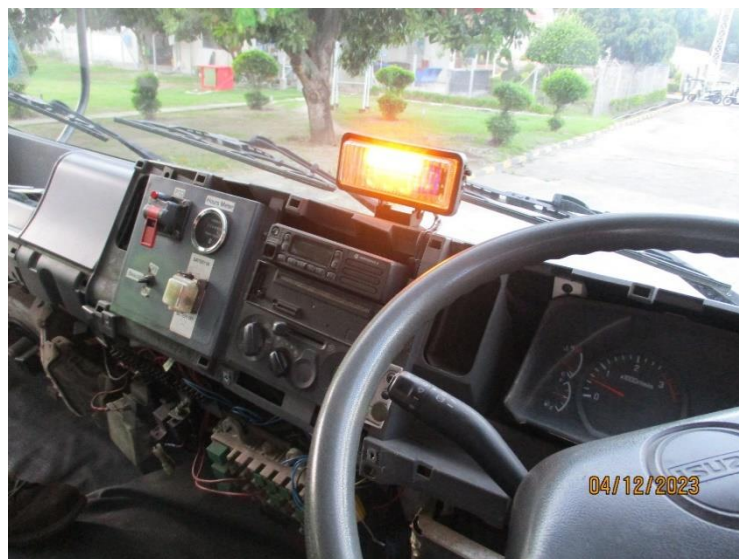
**FIGURE 3.** Emergency fuel stop on indicator

When checking the performance, the tool can work well in accordance with the expected sequence and purpose, as in Figure 3, which shows the emergency fuel stop LED indicator light is active. Checking work sequences and procedures can be seen in Table 1 with 2 case conditions, namely case 1: emergency engine active and case 2: emergency fuel active,

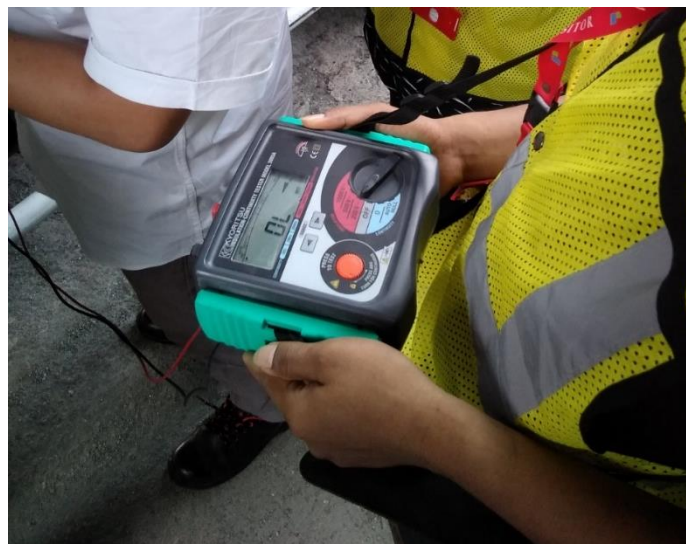
**FIGURE 4.** Insulation resistance test results using a megger

The results of the Megger test that was carried out during the testing activity showed an OL (Over Load) value as in Figure 4. The OL value indicates that the insulation resistance of the tool being tested is outside the measurable range/extensive, so this condition is very safe.

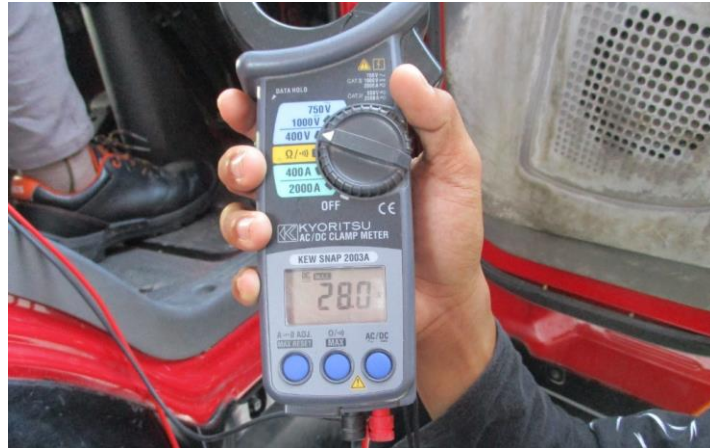
FIGURE 5. Results of stress testing on the ESI tool

resistance, reactance, and impedance in the line. The voltage drop on the line is the difference between the voltage at the base of the shipment and the voltage at the receiving end of electricity (Hermanu & Apribowo, 2019). Measurements are also divided into two parts, namely, when conditions are without load and when conditions are with load. The voltage source used in the ESI tool is 24-28 Vdc. During testing, the voltage at the ends of the terminals remained at 28 Vdc, as shown in Figure 5. These results show that there is no voltage drop when the system is activated.

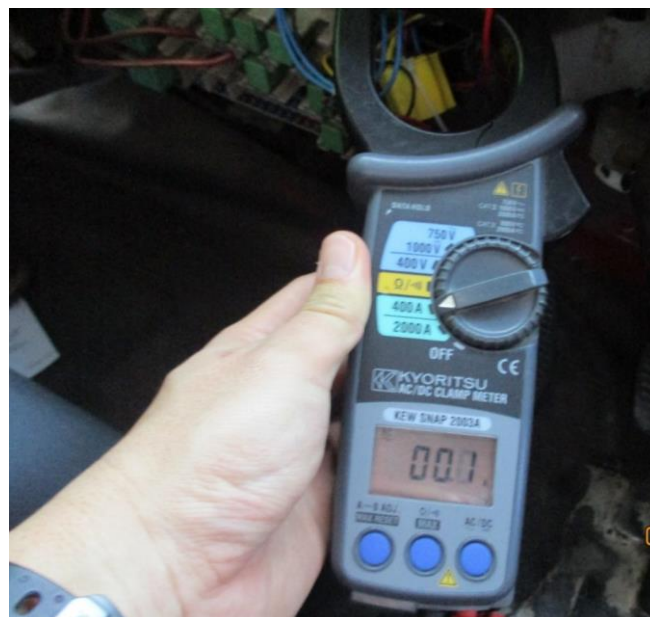
FIGURE 6. Results of leakage current testing on the ESI tool

Another component parameter test is leakage current testing. This test can also indicate the security of a device. Leakage current is a current that occurs if the conductor insulation cannot meet applicable standards, both between conductors and the earth (Olesz et al., 2023). So, the presence of this leakage current can indicate a disturbance or insecurity in the conductor. The leakage current is required to determine the longterm capability of the outdoor epoxy resin insulators (Utami et al., 2021). The leakage current limit, according to the standard, is less than 1 mA. The leakage current that occurs can be influenced by the humidity temperature of a voltage because the higher the humidity temperature, the greater the current that crosses and enters the circuit. The results of the leakage current test on the ESI tool are shown in Figure 6.

The three electrical parameter test results are summarized in Table 2 with reference to safe standards based on applicable electrical standards. The standard used is the 2011 General Electrical Installation Regulations standard. Based on the applicable standard, the working voltage must not be less than -10% (Badan Standardisasi Nasional (BSN), 2014), this can be fulfilled by the ESIn device with no voltage drop at the end of the circuit or -0% of nominal voltage. The insulation resistance measurement value that shows the OL value means the insulation resistance value is more than 1M $\Omega$  at a test voltage of 500V (Nada Fitsa Alfazumi1, 2020). including in conditions that comply with the standard. Likewise, the leakage current's value is 0.01A or far below 0.6A(Technical Committtee 64, 2016). The test results obtained measurement values that still met the standards and were even included in good values.
